Manhole Inspection Summary

Manhole # S47II_036MH

Inspection ☐ Is Incomplete Rating: **3) Fair**

Location Address: **Oliver**

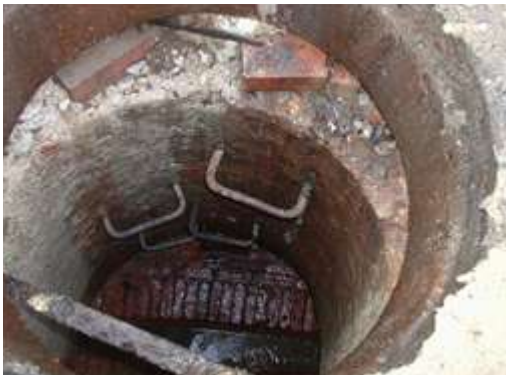
Defect 2

Condition: ☐ Sound ☐ Cracked ☐ Root Intrusion ☒ **Loose Brick** ☐ Deteriorated

Infiltration: ☐ None ☒ **Joint** ☐ Cracks ☒ **Mortar** ☐ Roots ☐ Wall

Loose Bricks

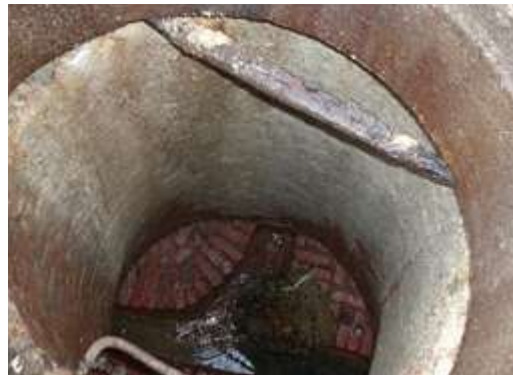
Defect 1

Frame Offset: **4** (in.) Condition: ☒ Sound ☐ Cracked ☐ Leaks

Offset Frame

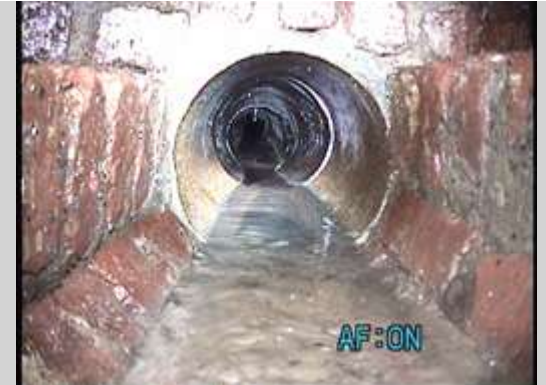
12 O'Clock Outflow

8 in. Circular Gravity Sewer
Pipe Out @ 12 O'Clock

Pipe Height: **8.4** (in.) Rod and Bar (Angled)
Pipe Material: **Clay** ☐ Pipe Lined
Invert Depth: **9.10** (ft.) Flow Characteristics: **Slow**
Deposits: ☒ None ☐ Mud ☐ Sludge ☐ Debris ☐ Grease
Silt Depth: (in.) Deposits Extent:
Infiltration: **None** Pipe Seal Cond: **Sound**

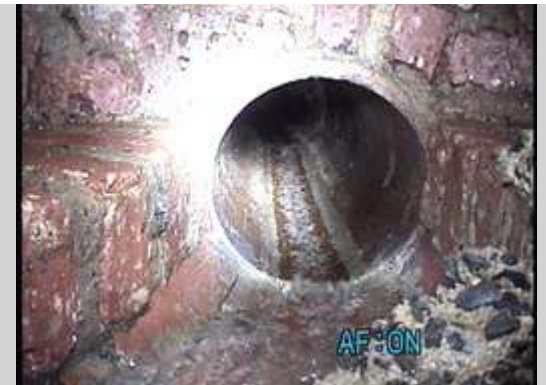
6 O'Clock Inflow

8 in. Circular Gravity Sewer
Pipe In @ 6 O'Clock

Pipe Height: **8.4** (in.) Rod and Bar (Angled)
Pipe Material: **Clay** ☐ Pipe Lined
Invert Depth: **8.75** (ft.) Flow Characteristics: **Slow**
Deposits: ☒ None ☐ Mud ☐ Sludge ☐ Debris ☐ Grease
Silt Depth: (in.) Deposits Extent:
Infiltration: **None** Pipe Seal Cond: **Sound**

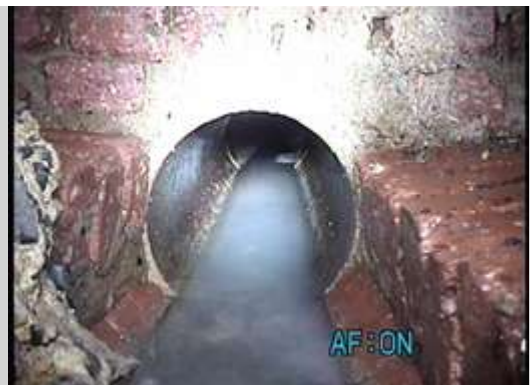
9 O'Clock Inflow

8 in. Circular Gravity Sewer

Pipe In @ 9 O'Clock

Infiltration: **None** Pipe Seal Cond: **Sound**
